SERVICE BULLETIN

No. 192

Piper Aircraft Corporation

SUBJECT: Throttle Limit Switch Bracket

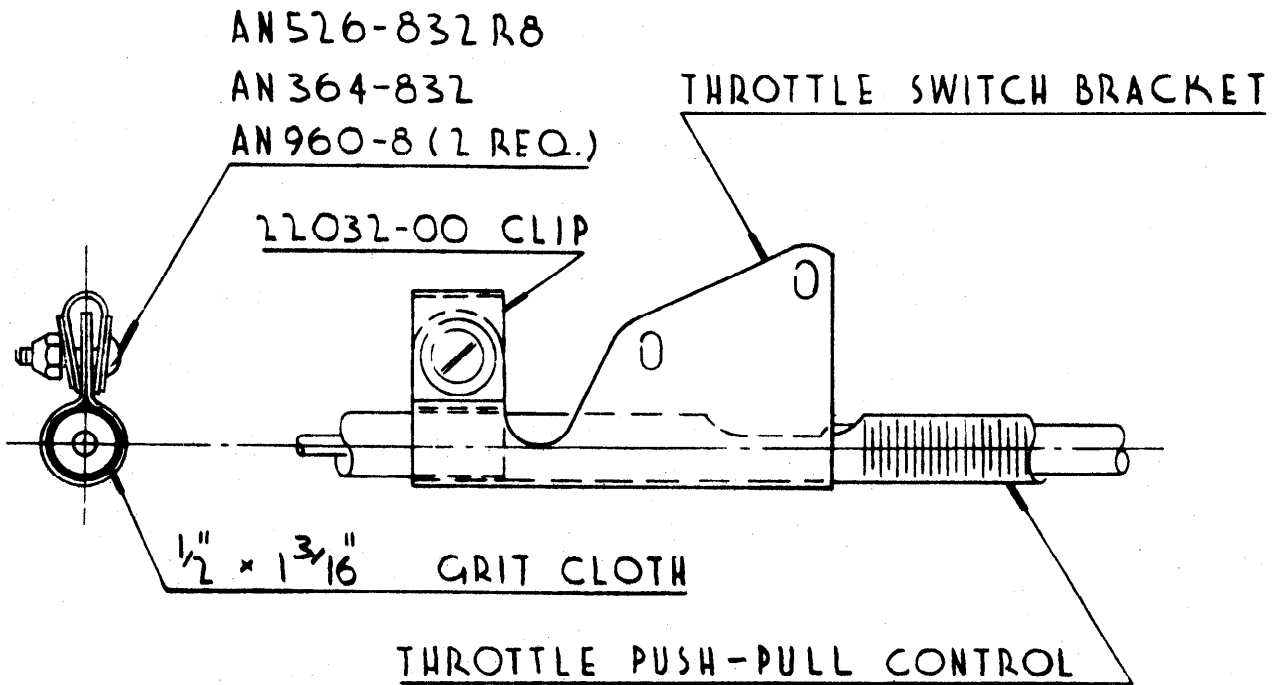
REVISED INSTALLATION
OF
THROTTLE LIMIT SWITCH BRACKET 21246-00

The Service Department has been advised that a movement of the throttle switch bracket during operating conditions has been noted. The movement of this bracket will vary the timing of the landing gear warning horn. To insure a more positive installation of the throttle switch, a piece of grit cloth and a clip shall be installed as per the sketch on the reverse side of this bulletin.
