SERVICE No.324 BULLETIN

Piper Aircraft Corporation

Subject: Vacuum Pump Adapter Drive Assembly

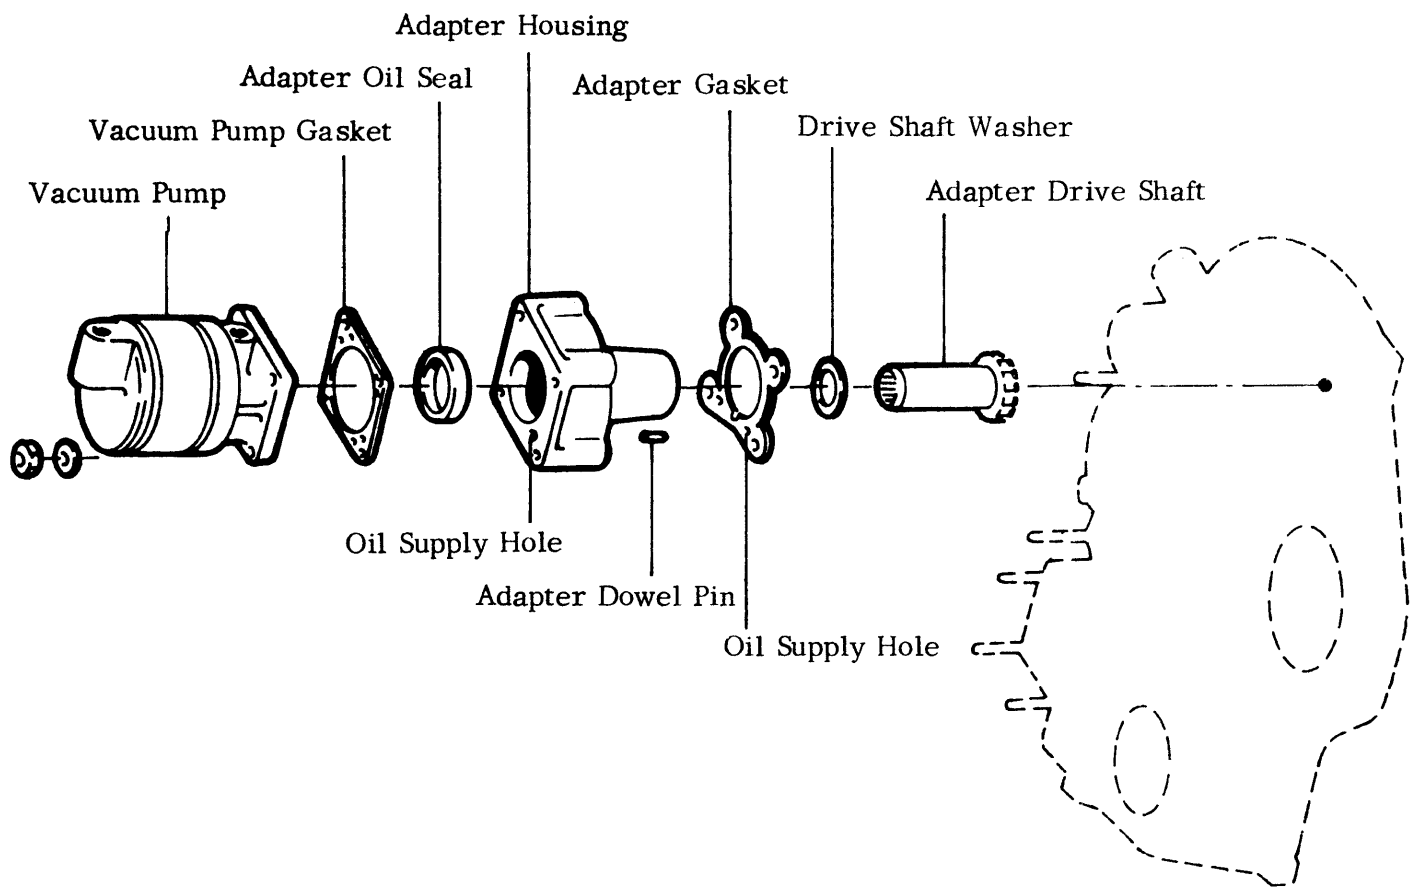
To provide instructions for an inspection of the vacuum pump adapter drive assembly (reference attached sketch for an illustration of the area to be inspected).

- I. Remove vacuum pump and vacuum pump adapter assembly from engine.
- II. Remove drive shaft from adapter housing and inspect the shaft for any sign of aluminum pick up on shaft at either end of shaft where it contacts adapter bearing bore.
- III. Inspect the adapter housing for the following:
 - a. Any evidence of inadequate lubrication resulting from foreign chips in oil supply hole.
 - b. Omission of oil supply hole.
 - c. Improper location of dowel.
 - d. Improper indexing of drive adapter assembly to accessory pad.
- IV. Inspect gasket, Lycoming part number 61183, for omission of oil transfer hole.

IF ANY DISCREPANCIES ARE FOUND, DO NOT ATTEMPT TO REPAIR. Contact your local Lycoming Regional Representative or Lycoming Service Department for further instructions.

- V. If the above referenced inspection procedure discloses no discrepancies, clean and lubricate (with SAE 50 oil) all parts that were inspected and reinstall on engine; torque all nuts to 50 to 70 inch pounds.
