# SERVICE *No.884* BULLETIN

Piper Aircraft Corporation  
Vero Beach, Florida, U.S.A.

SUBJECT:

Lock Wiring of V-Band Couplings

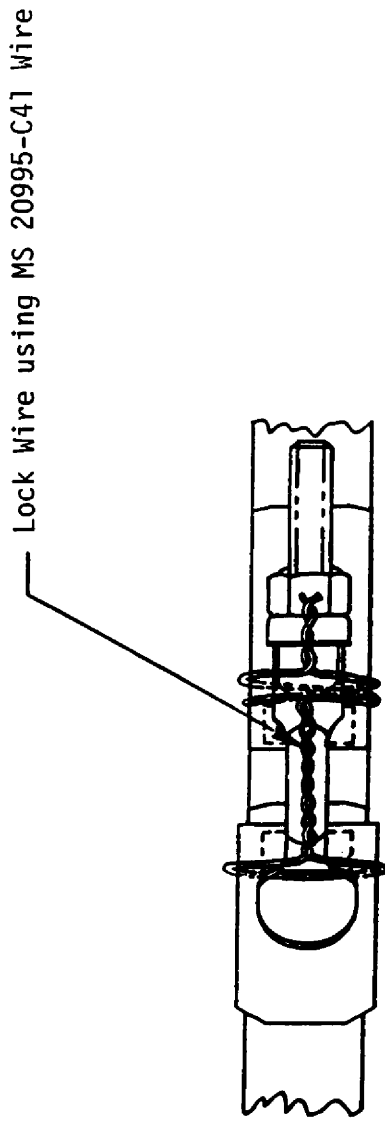
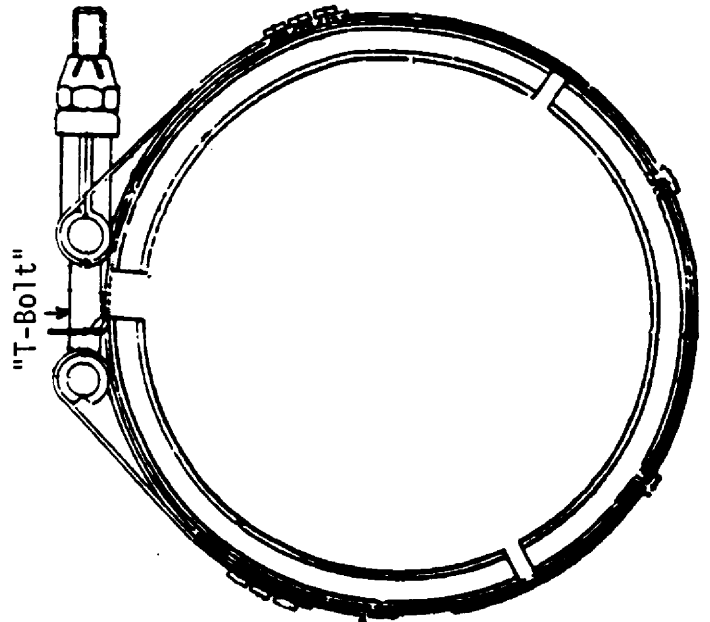
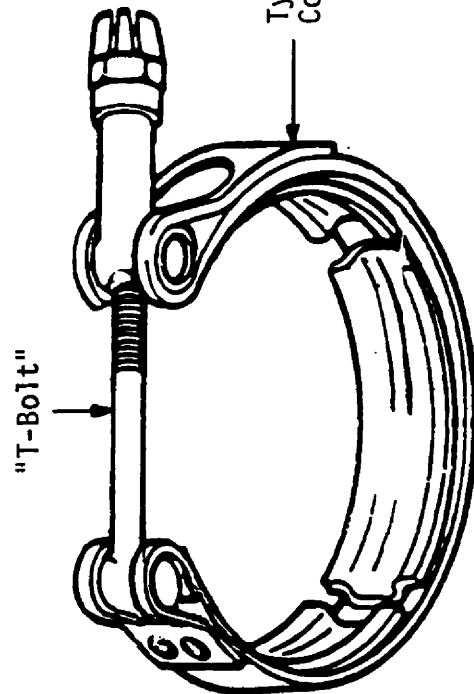
SKETCH "A"

**PURPOSE:** Reports have been received of broken "T-bolts" in the V-Band Couplings used in the exhaust, bleed air and cabin heat systems on various Piper Airplanes. The failure of a T-bolt can allow the coupling to separate, permitting hot exhaust gases or bleed air to be expelled, creating a fire hazard.

Typical V-Band Coupling

1. Refer to the applicable parts catalog to determine the number and location of V-Band Couplings on the affected aircraft.
2. Inspect all V-Band Couplings for security and integrity of T-bolts and lock wire (if installed). Refer to Sketch "A" attached.
3. If lock wire is damaged or missing, lock wire coupling using MS20995-C41 wire. Refer to Sketch "A".
4. Make an appropriate logbook entry of compliance with this Service Bulletin.
