SERVICE No. 1035A BULLETIN

Distribution of Textron Lycoming Service Bulletin 529B, "Reprint of Crane/Lear/Romec Service Bulletin No. 101SB020, Rev. 3"

Service Bulletin No. 529B
(Supersedes Service Bulletin No. 529A)
Engineering Aspects are
FAA Approved

FUEL PUMP – Torquing of Relief Valve Cover Screws.

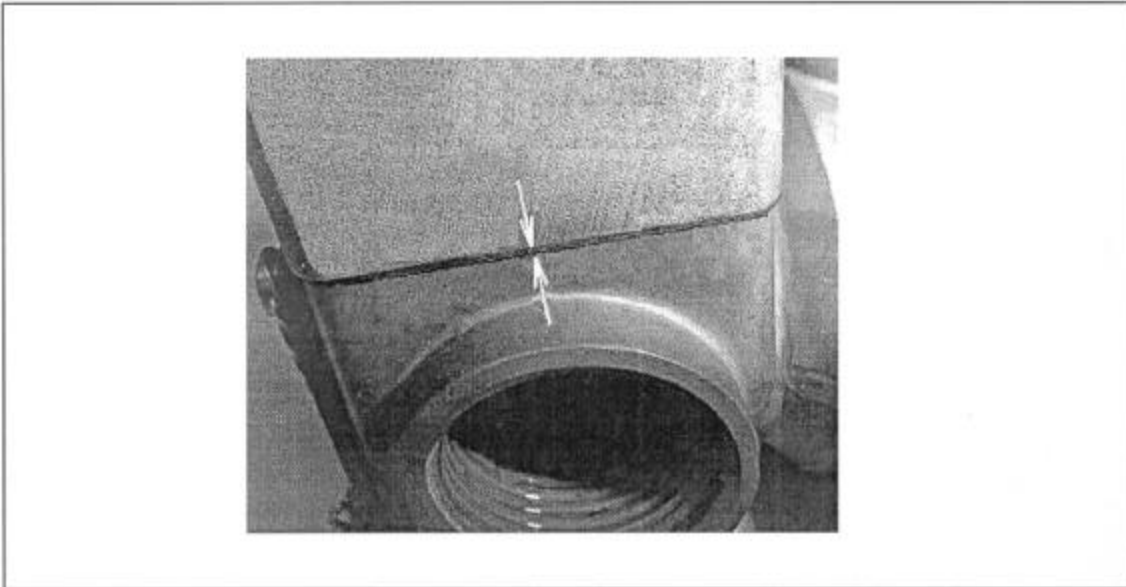
Normal Extrusion – All Series
Figure 3

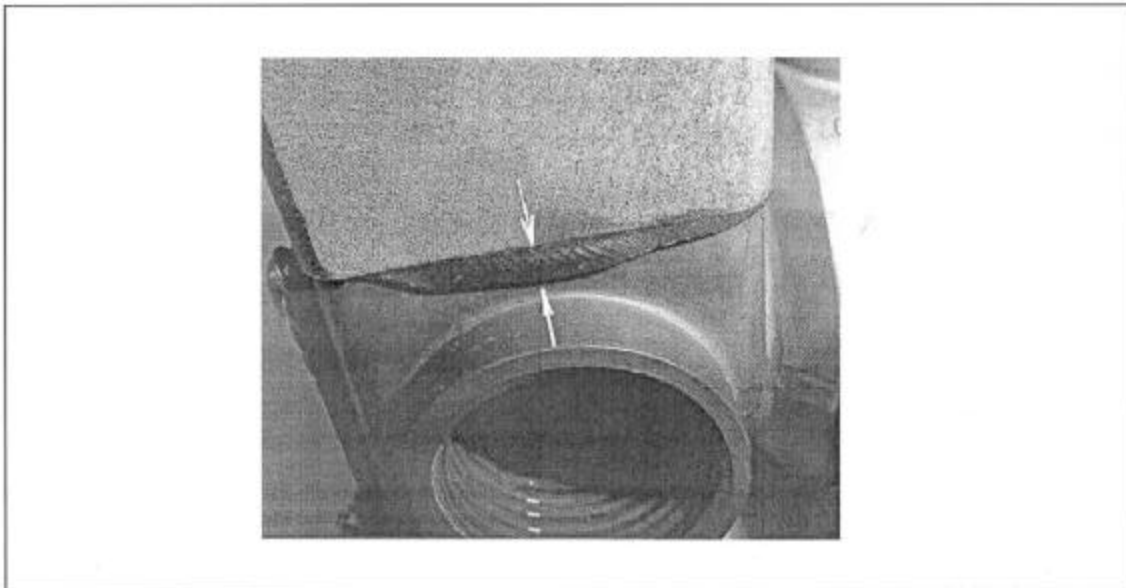
There have been field reports of fuel leakage past the relief valve gasket on several of the above listed fuel pumps. This condition could result in a fire hazard, fuel flow fluctuation, or engine stoppage.

Excessive Extrusion – All Series
Figure 4

- (a) Visually inspect the split lines between the pump housing, relief valve housing and relief valve cover for evidence of fuel leakage or noticeable gasket extrusion adjacent to the pump inlet and outlet ports. If there is evidence of fuel leakage or noticeable extrusion, replace the pump per applicable engine maintenance instructions. (See figures 1,2,3 & 4.)
- (b) Check the tightness of relief valve cover attaching screws using a torque indicating screwdriver. Minimum torque shall be 23 inch-pounds. Torque shall be checked in the tightening direction.
