SERVICE BULLETIN

NO. 1266

Date: December 16, 2014

FUEL WARNING PLACARD AND POH INSPECTION

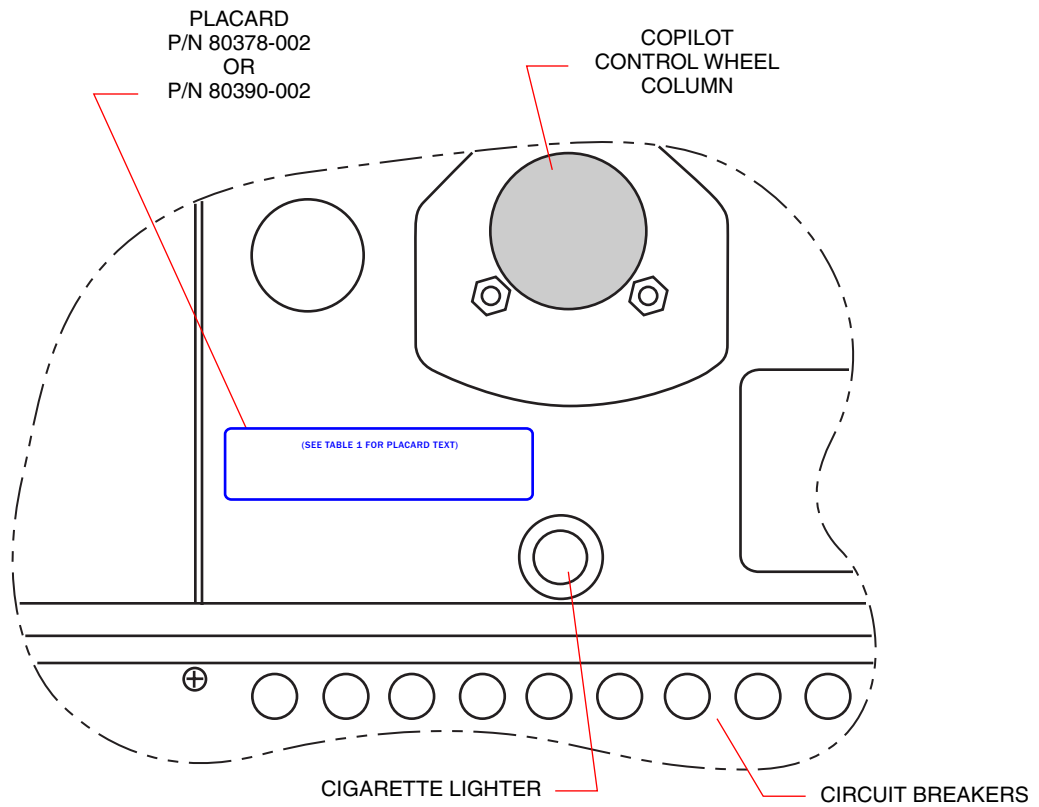
Figure 1
Warning Placard - PA-24-250 (FI), PA-24-260 (FI), PA-24-260 "C" and PA-24-400 Comanche

WARNING PLACARD, LOWER RIGHT SIDE OF INSTRUMENT PANEL

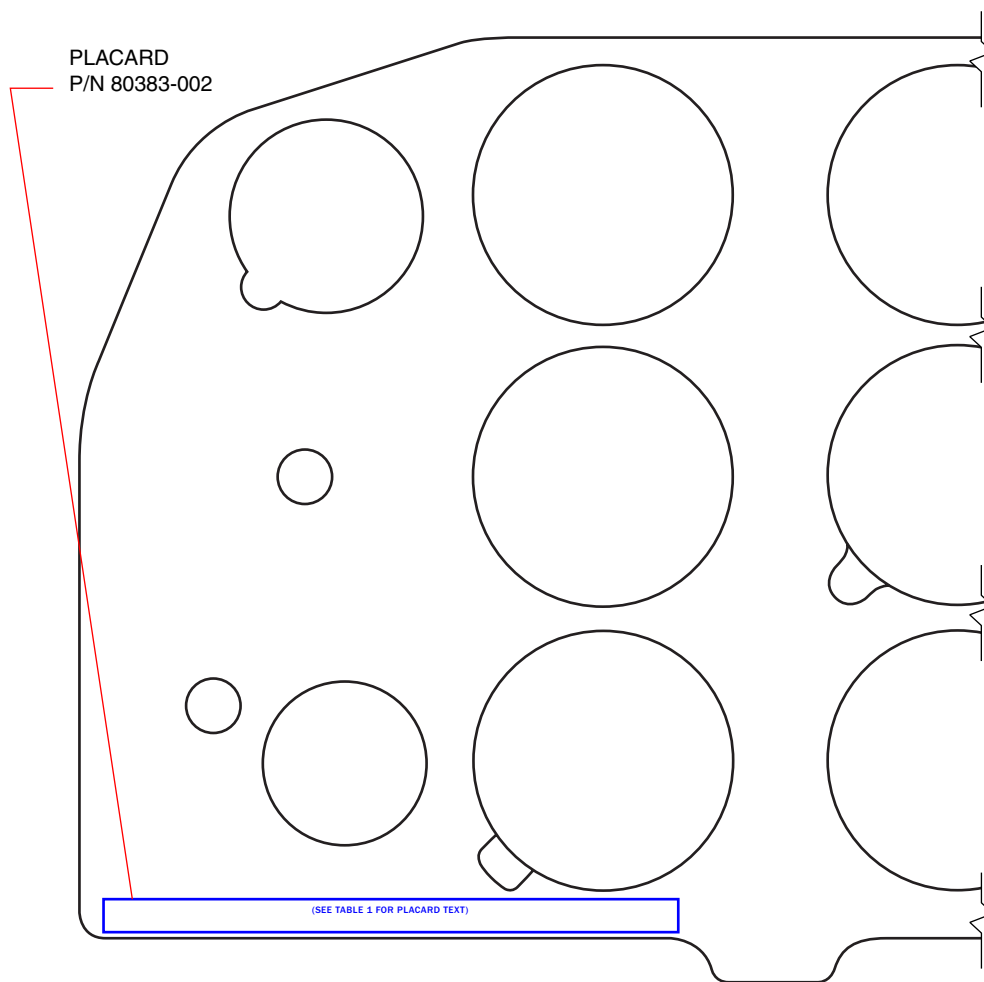
Figure 2
Warning Placard - PA-31 and PA-31-300

WARNING PLACARD, LOWER LEFT CORNER OF LEFT INSTRUMENT PANEL

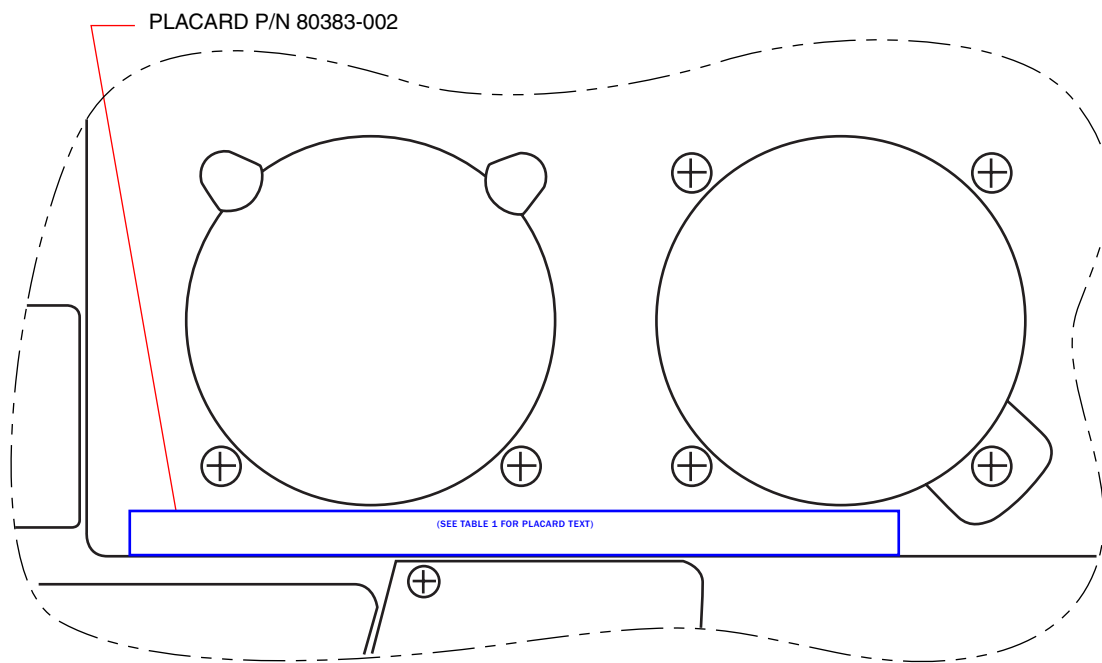
Figure 3
Warning Placard - PA-31P Navajo

WARNING PLACARD, LOWER LEFT CORNER OF MAIN INSTRUMENT PANEL

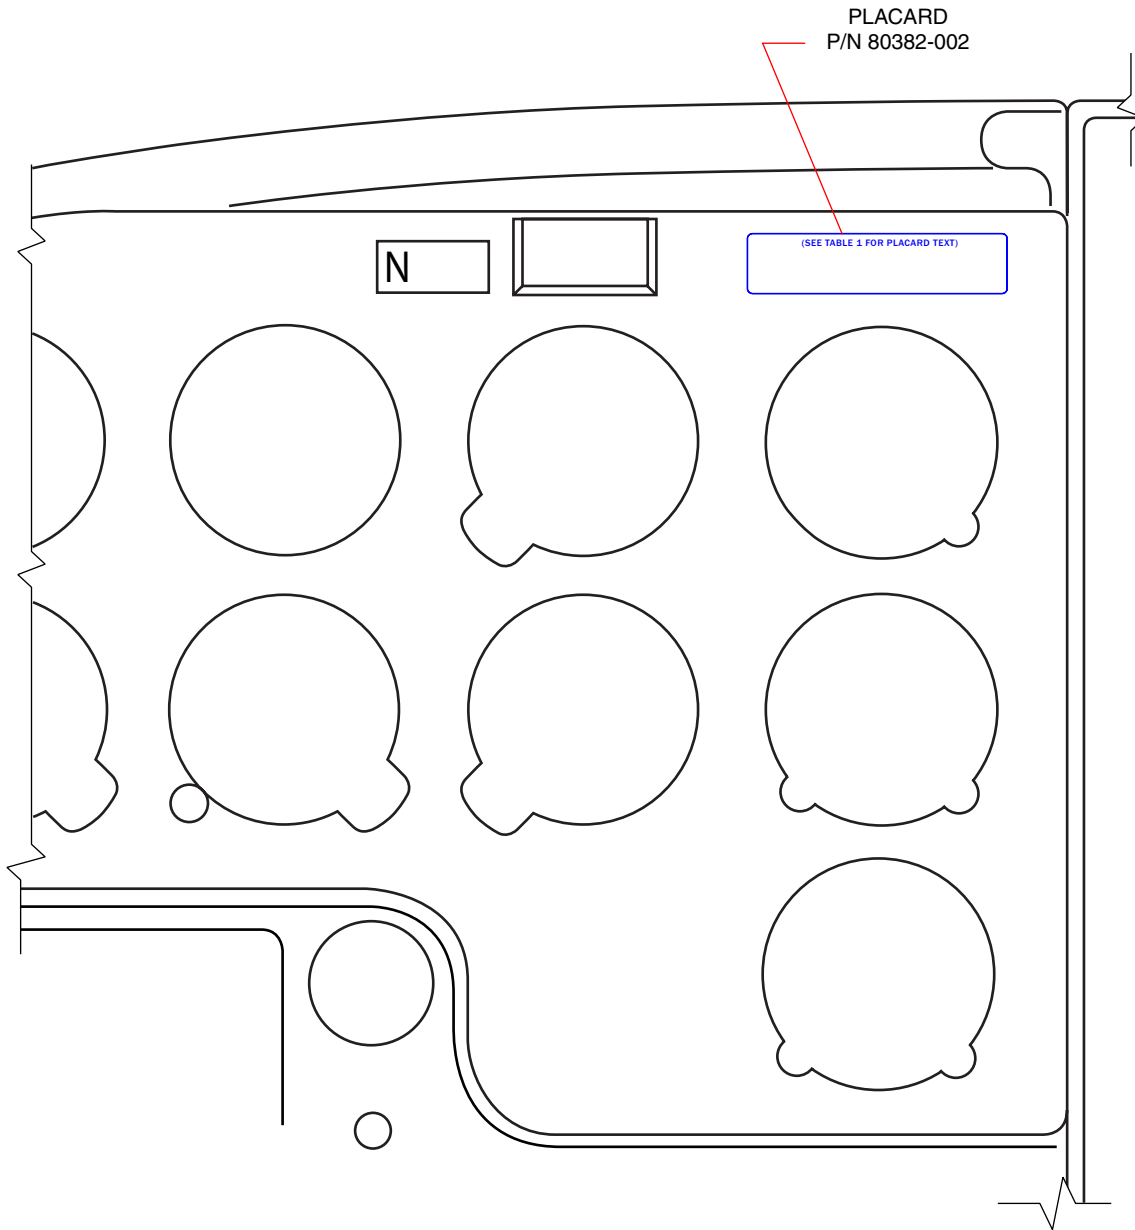
Figure 4
Warning Placard - PA-23-250 and 23E-250 Aztec (six-place) "B," "C," "D," and "E"

WARNING PLACARD, UPPER LEFT INSTRUMENT PANEL,
ADJACENT TO THE COMPASS DEVIATION CARD
AZTEC "E" SHOWN
