Piper Aircraft, Inc.
2926 Piper Drive
Vero Beach, FL, U.S.A. 32960

SERVICE NO. 1286A BULLETIN

LYCOMING SERVICE BULLETIN NO. 621B

SUBJECT: Diaphragm-Type Fuel Pump Replacement

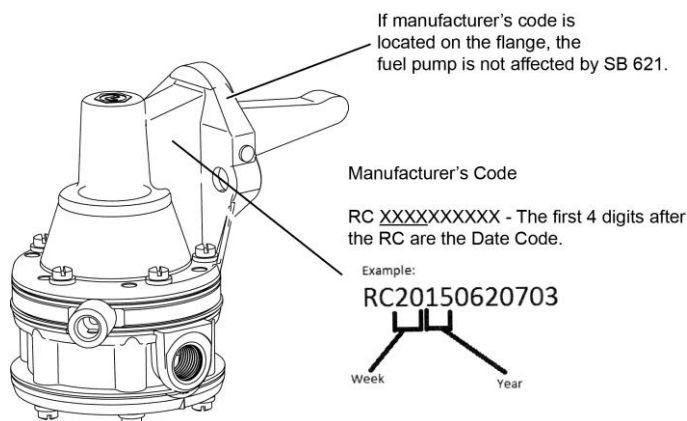
Figure 1
Manufacturer's Code Location on
Fuel Pump P/Ns 62B26931 and LW-16335

1. If the fuel pump is Lycoming part number 62B26931 or LW-16335 (ordered and sold as LW-16335-S but marked on fuel pump as LW-16335).
2. If the manufacturer's code is not on the flange but is on the web or other parts of the fuel pump.
3. If the fuel pump has **RC** (Figure 1) as the first two letters of the manufacturer's code.
4. If the manufacturer's code identifies the fuel pump as manufactured before, up to, and including the 25th week of 2015.

If any fuel pump meets **all** the criteria above, remove the fuel pump from the engine or from the spares inventory and:

- A. Review your records to identify shipping dates of the serial numbers of any of the affected fuel pumps.
- B. Return all affected fuel pumps to Lycoming Engines with a copy of this Service Bulletin and file a warranty claim per the warranty procedure herein.
- C. Record removal of the fuel pump installed on the engine in the engine logbook.
