SERVICE Mo.210 BULLETIN

Piper Aircraft Corporation

Replacement or Modification of Muffler Shrouds

PA-24 and PA-24 "250" Comanches - Serial Numbers 24-2588 to 24-2875 incl., 24-2877 to 24-2928 incl., 24-2930 to 24-2948 incl., 24-2950 to 24-2966 incl., 24-2968 to 24-2989 incl., 24-2991 to 24-3032 incl., 24-3034 to 24-3094 incl., 24-3096 to 24-3113 incl., 24-3115 to 24-3129 incl., 24-3131 to 24-3149 incl., 24-3151 to 24-3154 incl., 24-3156 to 24-3172 incl., 24-3174 to 24-3190 incl., 24-3192, 24-3195, 24-3197, 24-3199 to 24-3202 incl., 24-3205 to 24-3221 incl., 24-3223 to 24-3232 incl., 24-3235 to 24-3240 incl., 24-3242, 24-3243, 24-3245, 24-3246, 24-3247, 24-3249 to 24-3253 incl., 24-3255, 24-3256, 24-3259 to 24-3264 incl., 24-3266, 24-3267, 24-3269, 24-3271, 24-3272, 24-3275, 24-3281, 24-3284 and all of the referenced aircraft prior to Serial No. 24-2588 in which mufflers, part number 22594-00 and part number 22594-02 PA-24, and part number 22593-00 and part number 23159-00 PA-24 "250", have been installed as service replacements.

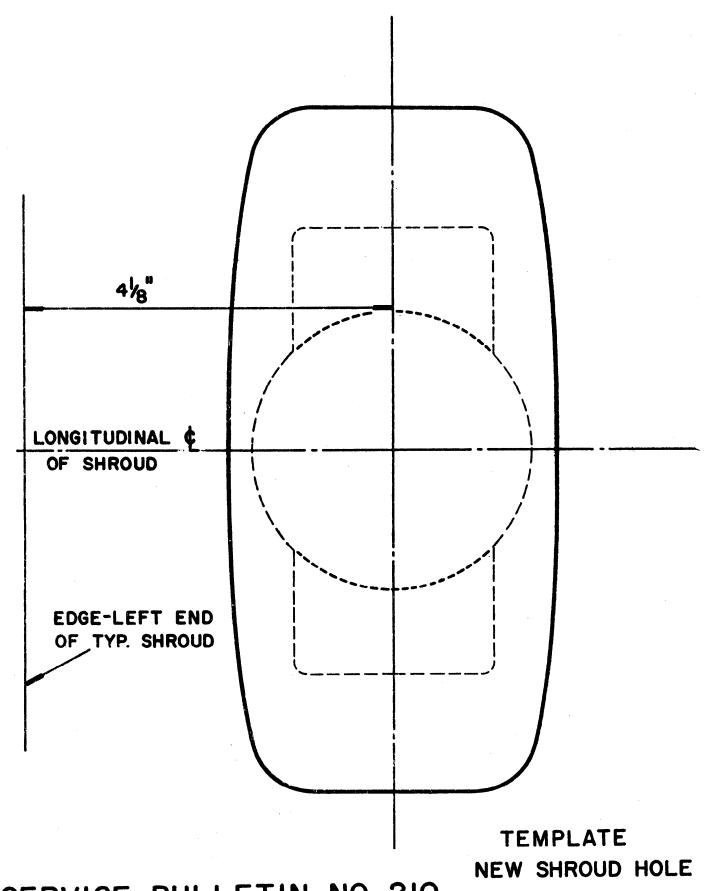
Service reports have been received advising of cracks located in the muffler housing near the tailpipe reinforcement strap. The muffler heater shroud has therefore been redesigned to remove the affected area from the heater system. This has been accomplished by increasing the shroud opening around the tailpipe, making the area more accessible for inspection.

Comanche mufflers have been manufactured incorporating two different styles of tailpipe reinforcement brackets. However, this Service Bulletin requires modification of one style only; those with the channel-shaped reinforcement. See Sketch "A" for further identification. Both styles of muffler have been sold as service replacements. It will therefore be necessary to inspect aircraft, Serial Nos. 24-1 to 24-2587 inclusive if the original muffler has been replaced, to determine if compliance with this Bulletin is required.

- 8. Cut the new opening in the aluminum shroud, taking care not to cut past the splice. (See Note Sketch "B.")
- 9. Install the muffler housing reinforcement tube, part number 23482-00, on the inside of the aluminum heater shroud. (See Sketch "B.")

- 10. Relocate the cold air inlet take-off assembly as shown on the take-off relocation table and install cover plate, part number 23498-00, over old hole. Trim cover plate as required. (See Sketch "B.")
