# SERVICE BULLETIN

No. 222A

Piper Aircraft Corporation

- SUBJECT:** Removal of Restriction to Air Speed Limits  
(Replacement of Stabilator Torque Tube)
- MODELS AFFECTED:** PA-30 Twin Comanches, Serials 30-1 to 30-482 incl., 30-484 to 30-491 incl., 30-493, 30-494, 30-496 to 30-502 incl., 30-504, 30-505, 30-507 to 30-565 incl.
- NOTE:** Serial Numbers 30-483, 30-492, 30-495, 30-503 and 30-506 have been modified at the factory and require only removal of placard and temporary supplement to flight manual for compliance.
- COMPLIANCE DATE:** Prior to but not later than 10 hours of operation after receipt of stabilator torque tube.

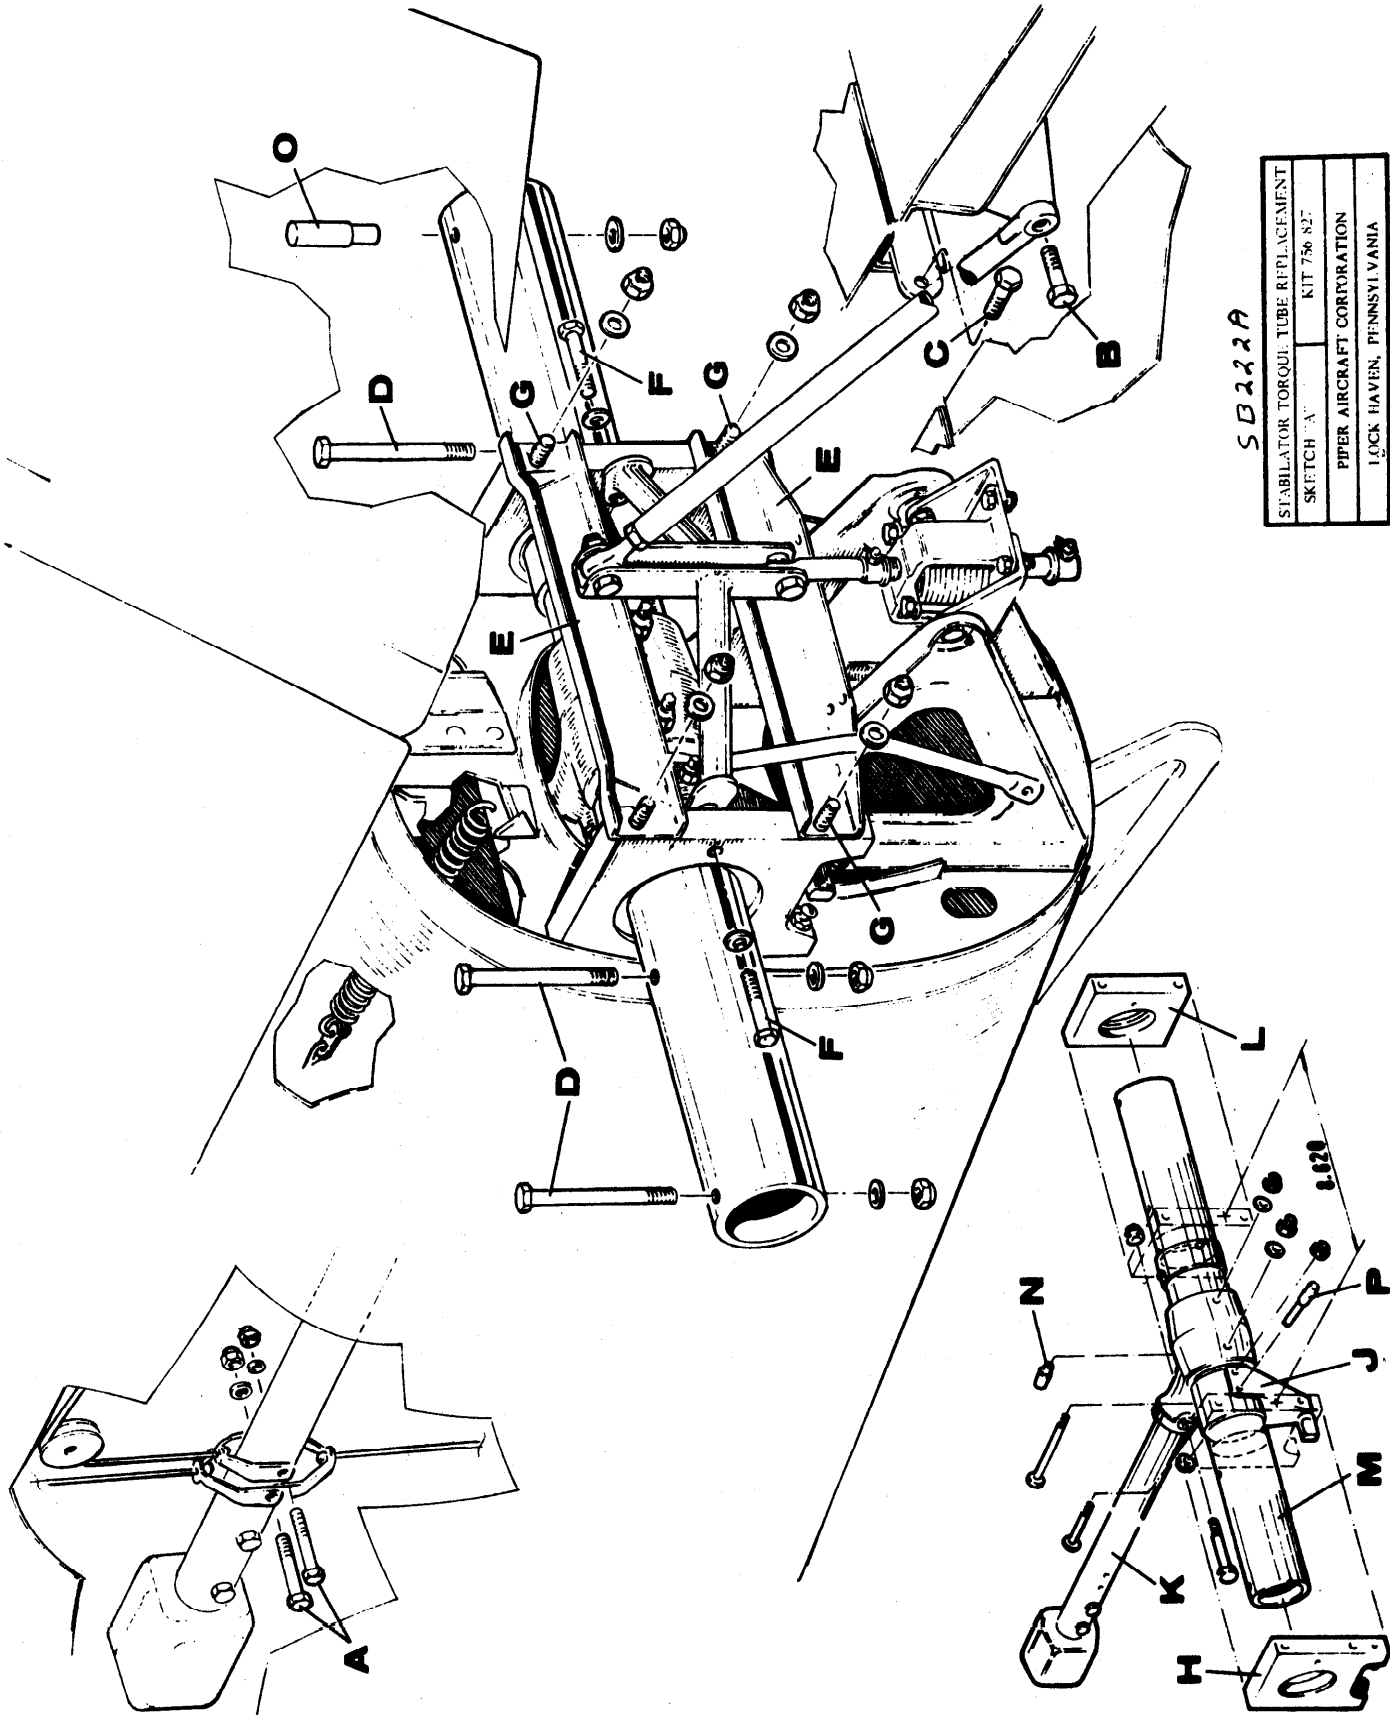
STABILATOR TORQUE TUBE REPLACEMENT
SKETCH "A"
KIT 756 827
PIPER AIRCRAFT CORPORATION
LOCK HAVEN, PENNSYLVANIA

Owners and operators of the subject aircraft were advised recently that because vibration at approximately the red line not-to-exceed limit had been observed, it was necessary to restrict the air speed.

It has been determined that a stabilator torque tube, part number 22655-07, of heavier wall thickness will eliminate this vibration.

1. Remove fuselage access cover plate.
2. Disconnect stabilator control cables on balance weight arm. Item A.
3. Remove bolt from stabilator trim tab born. Item B.

4. Remove bolt from stabilator rear spar. Item C.
5. Remove four bolts attaching stabilator to stabilator torque tube and remove stabilators. Item D.
6. Remove top and bottom fuselage tail fairings.

7. Remove stabilator bearing block reinforcement channels. Item E.
8. Remove two bolts holding stabilator tab control bellcrank assembly to stabilator bearing blocks. (It is not necessary to further disassemble this unit.) Item F.

9. Remove the bolts from the right stabilator bearing block and the bottom bolt in the left bearing block. DO NOT REMOVE the top bolt in the left bearing block. Item G. (Caution - Mark top for proper reassembly.)

10. By pulling rearward and rotating the right end of the stabilator torque tube downward to pass the rudder arm, the entire torque tube and counterbalance assembly can be removed from the aircraft. The top left bearing block bolt should stay in place.

11. During disassembly of the torque tube assembly note the position of parts so that it can be properly reassembled.
12. Remove left bearing block by tapping with a soft mallet. Note shims, part number 81262-72, if installed. Item H.

13. Remove stop assembly. Item J.
14. Remove counterbalance arm assembly. Item K.
15. Remove right bearing block assembly. Note shims (81262-72) if installed. Item L.

16. Install counterbalance arm assembly on new stabilator torque tube, part number 22655-07. Note position in View B. Item M.

17. Install stop assembly referring to Item J.

18. Install left bearing block, Item H, right bearing block, Item L.

Shims, part no. 81262-72, should be installed with bearing blocks in same position as when removed to maintain a dimension of 8.620 shown in View C.

19. Reinstall torque tube assembly on aircraft in reverse order of disassembly.
20. Install stabilators and bolt the rear spar. Insert locating pin in same manner as previously used in one hole on either stabilator. Ream the other hole to .3120 to .3130 and install bolt. Item O.

21. Connect control cables and complete reassembly of fairings. Item A.
