SERVICE BULLETIN

No. 354B

Piper Aircraft Corporation

Subject: Fuel Selector Valve Lubrication

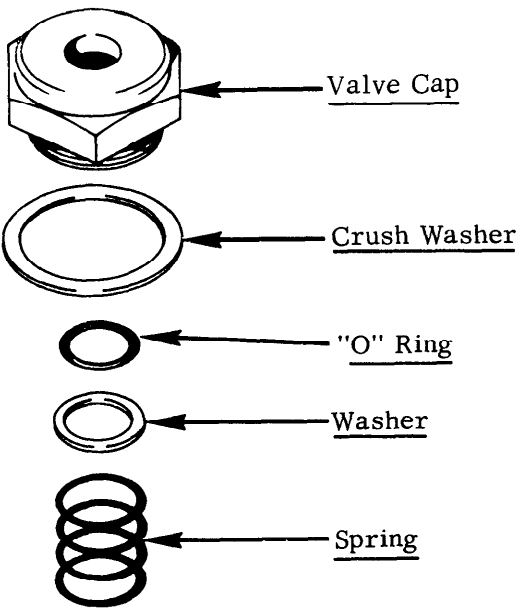
Position Washer

Brass Washer - counterbored; to reinstall properly, counterbored surface must face the position washer.

1. Check inside perimeter for indication of extreme wear; if wear is readily apparent, replace position washer.
2. Lubricate with MIL-G-6032 (Type I) prior to reinstallation.

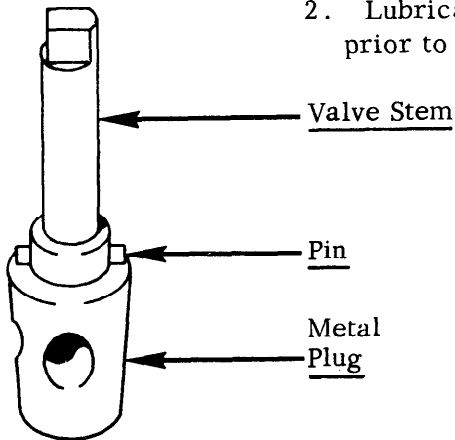
Metal Plug

3. Check condition of plug and valve body for scored surfaces. The surfaces, if not badly scored, may be conditioned by lapping with a fine grinding compound. Clean away all compound after lapping. If plug will not seat properly or if scoring remains evident, replace valve with Valve Replacement Kit 764 295.

6. Clean valve of all foreign matter, lubricate plug with a light film of MIL-G-6032 (Type I) grease, turn the plug several times in its seat and wipe off any excess, especially in the valve ports. Also, lubricate position washer with a light film of MIL-G-6032 (Type I) grease. Reassemble valve with a new "O" ring, Piper Part Number 752 822.
