SERVICE BULLETIN

No. 546

Piper Aircraft Corporation

Subject: Inspection of Whelen Wing Tip Strobe Lights; Reference F.A.A. Airworthiness Directive 75-05-04

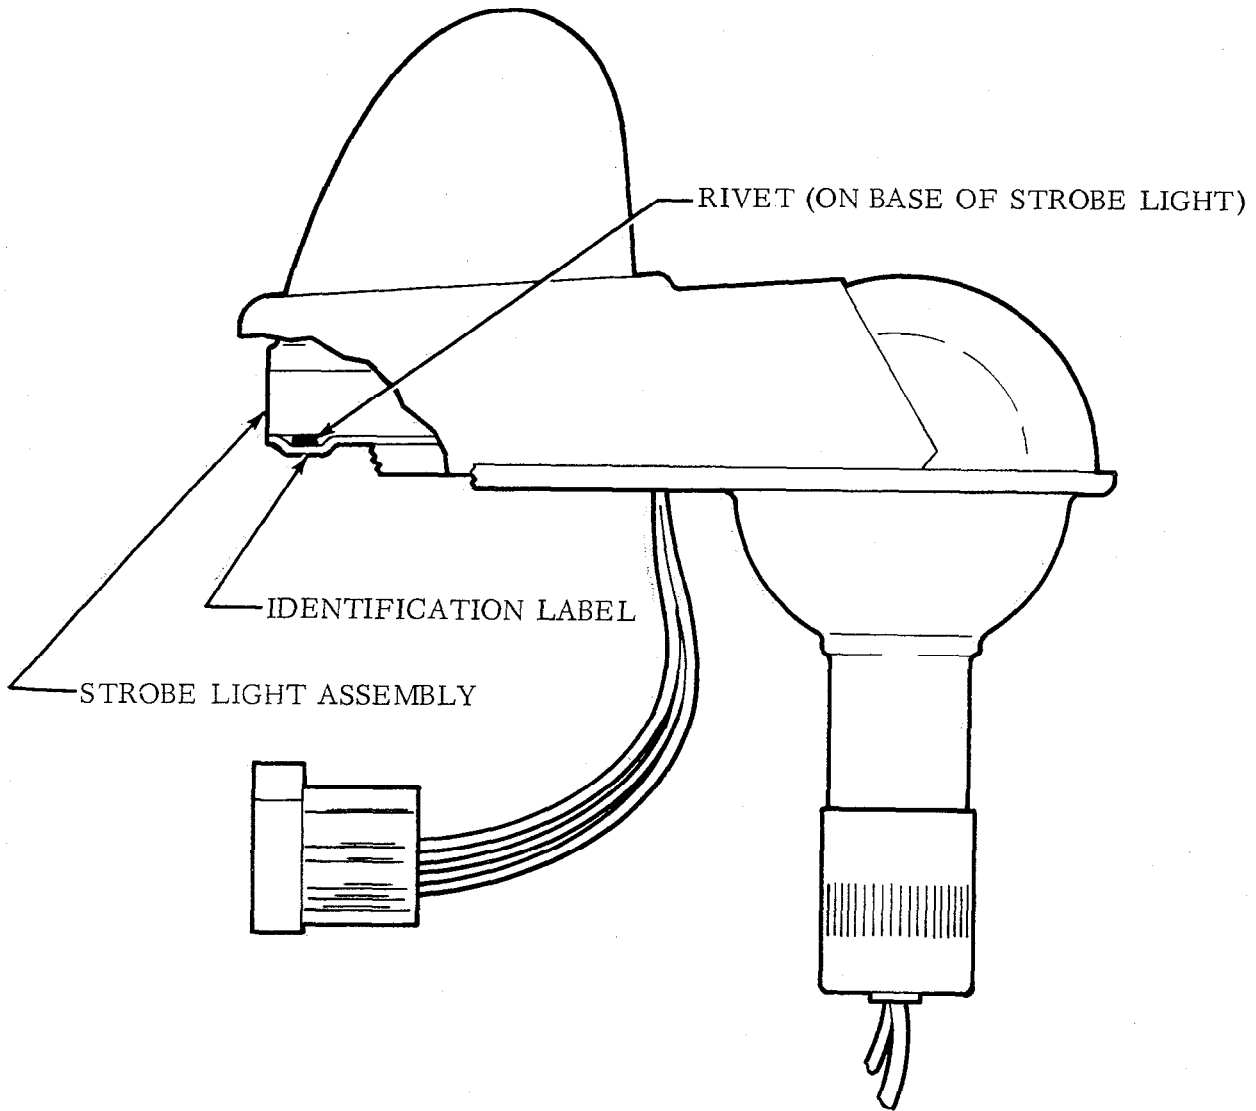
WHELEN NAVIGATION AND STROBE LIGHT ASSEMBLY

Purpose: The subject Airworthiness Directive was issued against the Whelen Engineering Company A-427 Strobe Light Assemblies "to preclude possible ignition of flammable fluids or vapors by arcing at the strobe light flash tube" (quoted from A.D. 75-05-04). The affected strobe light units may be installed as original equipment on the aircraft specified above, and it has been brought to our attention that a number of these strobe light units may not be in accordance with the subject Airworthiness Directive.

1. Expose wing tip strobe light assembly to view (refer to attached sketch for a typical strobe light assembly illustrated view).
2. If the following modification has already been accomplished, no further action is required; make appropriate entry in aircraft log book re compliance with this Service Release.

3. If the following modification has not been accomplished, proceed as follows:
 - a. Install on the base of the Whelen A-427 Flash Tube Assembly a pressure sensitive vinyl label conforming to Whelen drawing no. A-30052, Revision 1 dated October 15, 1974 or later F.A.A. approved revision.

1. Scotch Brand Type 33+ Vinyl Plastic electrical tape or equivalent tape - approved by an F.A.A. Maintenance/Avionics Inspector may be used in lieu of the vinyl label (if any plastic tape is used, it must be formed to cover the rivet at the rear of the flash tube without covering the identifying part number).

3. b. If the flash tube incorporates a label, the new label or tape may be installed directly over the old label.
- c. Install label or tape only when the label or tape and the flash tube are at a temperature above 50 degrees F.
4. Make appropriate service release compliance entry in aircraft log book.
