Service Letter No. 360

SUBJECT: Flap Retraction

MODELS AFFECTED: PA-24 and PA-24 "250" Comanches, Serials 24-1 to 24-356 inc., 24-358 to 24-1424 inc., 24-1426 to 24-2513 inc., 24-2515 to 24-2545 inc., 24-2549 to 24-2582 inc., 24-2584 to 24-2590 inc., 24-2593 to 24-2625 inc., 24-2627 to 24-2647 inc., 24-2649 to 24-2652 inc., 24-2655 to 24-2664 inc., 24-2666, 24-2668 to 24-2675 inc., 24-2677 to 24-2679 inc., 24-2681 to 24-2698 inc., 24-2700, 24-2701, 24-2702, 24-2704 to 24-2714 inc., 24-2716, 24-2718 to 24-2720 inc., 24-2722 to 24-2724 inc., 24-2726, 24-2728, 24-2730, 24-2732 to 24-2735 inc., 24-2737, 24-2738, 24-2742 to 24-2744 inc., 24-2746 to 24-2751 inc., 24-2755, 24-2758, 24-2761 to 24-2764 inc., 24-2770, 24-2773, 24-2774, 24-2776 to 24-2783 inc., 24-2787 to 24-2792, 24-2794, 24-2799, 24-2803, 24-2804, 24-2808 to 24-2810 inc., 24-2813, 24-2816, 24-2823, 24-2827, 24-2828, 24-2830, 24-2833 and 24-2834.

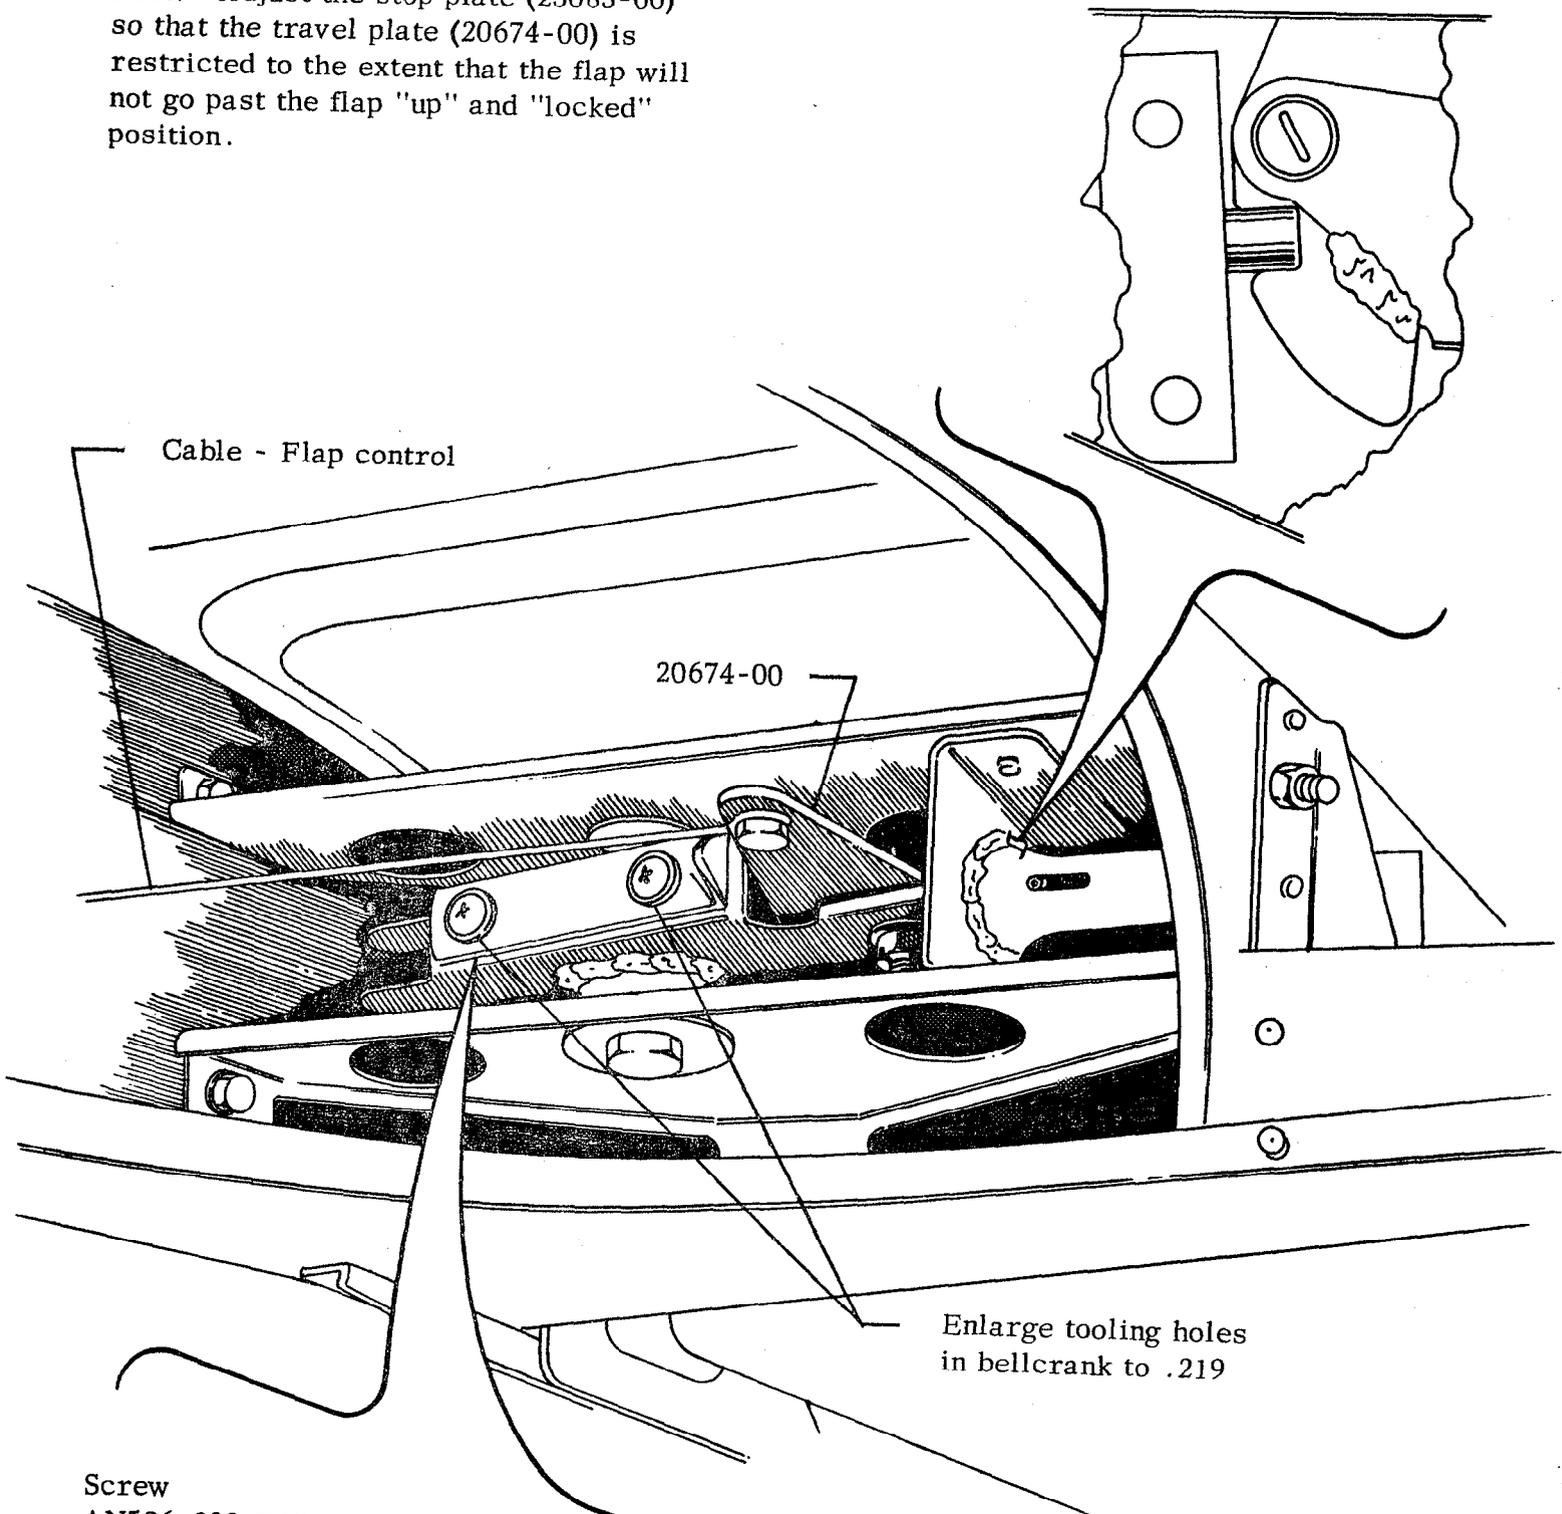
SERVICE LETTER NO. 360

Field service reports indicate that in a few cases, under certain operating conditions, the flaps on the subject aircraft may, when retracted, extend beyond the normal, fully retracted position. This over-retraction of the flap or flaps has resulted when the flaps have been extended to aid in take-off and, later, retracted at airspeeds in excess of speeds recommended for flap operation.

Note: Adjust the stop plate (23083-00) so that the travel plate (20674-00) is restricted to the extent that the flap will not go past the flap "up" and "locked" position.

Kit No. 754 413 consists of a flap stop plate for each flap, necessary hardware for its attachment and instructions for installation. This kit provides a positive stop for the flap retraction mechanism. Reference to the attached sketch may be made for details of installation. It is recommended that this kit be installed on all Comanche aircraft listed above for the serial numbers affected.

It is recommended that the operation of the flap retraction mechanism be checked, following the installation of Kit 754 413, to make certain the flap stop plates are correctly adjusted to prevent over-retraction of the flaps, as follows:
