Service Letter No. 431

Insulation of Motor Mounts

AIRCRAFT AFFECTED: PA-24 "250" Comanches - Serial Nos. 24-3558 to 24-3687

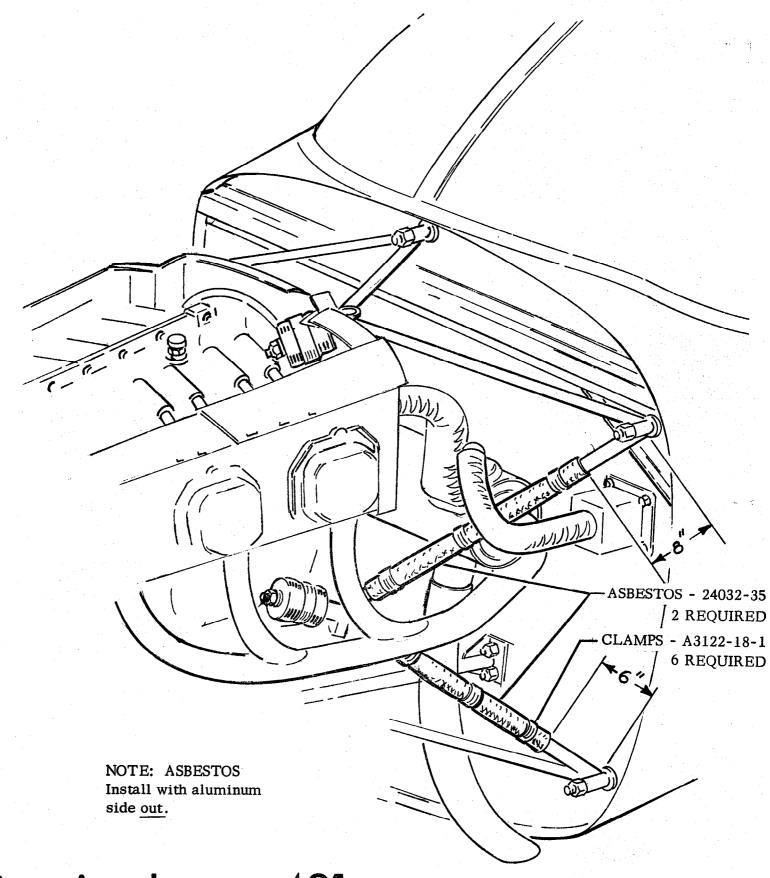
The aircraft indicated by the above serial numbers are equipped with a hollow type muffler. Service reports from the field indicate that, due to the construction of this hollow muffler, the engine mount tubes have shown evidence of heat at the end where the burned gases enter the tailpipe. This heat has resulted in two of the engine mount tubes becoming scorched and, in some cases, a slight amount of corrosion has been noted.

In order to protect these tubes, kit number 756 831, consisting of two (2) asbestos blankets and clamps, is available for installation and it is required that it be installed. See sketch on reverse side of this service letter.

Prior to the installation of kit number 756 831, the tubes should be cleaned to the bare metal and if pits are noted, they should be sanded until the metal surface is free of paint and pits. When necessary to remove pits by sanding, the tubes should not be sanded beyond a depth of .005 on either side. When the tube is cleaned of paint and any corrosion, the tube should then be painted; first with prime (either zinc chromate or red oxide) and then with two coats of any lacquer or enamel.
