Service Letter No. 459

October 6, 1965

SUBJECT:Mixture Control Cable ShieldMODELS AFFECTED:PA-24-400, Serial Nos. 26-1 to 26-124 inclusiveCOMPLIANCE DATE:At the next 50 hour inspection

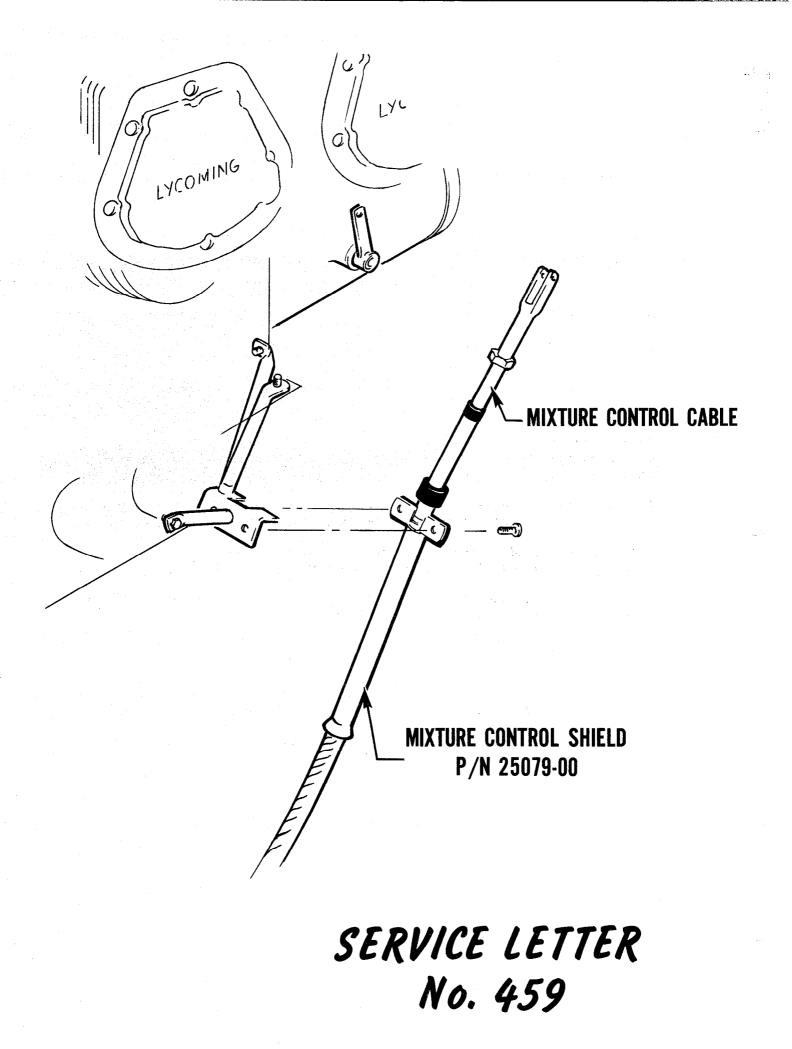
Several reports have been received of binding or broken mixture control cables on the PA-24-400. This binding or breaking has generally occurred in the engine compartment at the fuel injection servo end of the control.

A shield has been added in the engine compartment to protect the mixture control. (See sketch on the reverse side of this letter.)

This shield should be ordered under part number 25079-00. When this shield is installed discard clamp presently used.

The mixture control should be inspected for condition and proper operation before installation of shield 25079-00.
