Service Letter No. 305

October 1, 1958

MODEL AFFECTED: PA-24 Comanche, Serial Numbers Listed Below

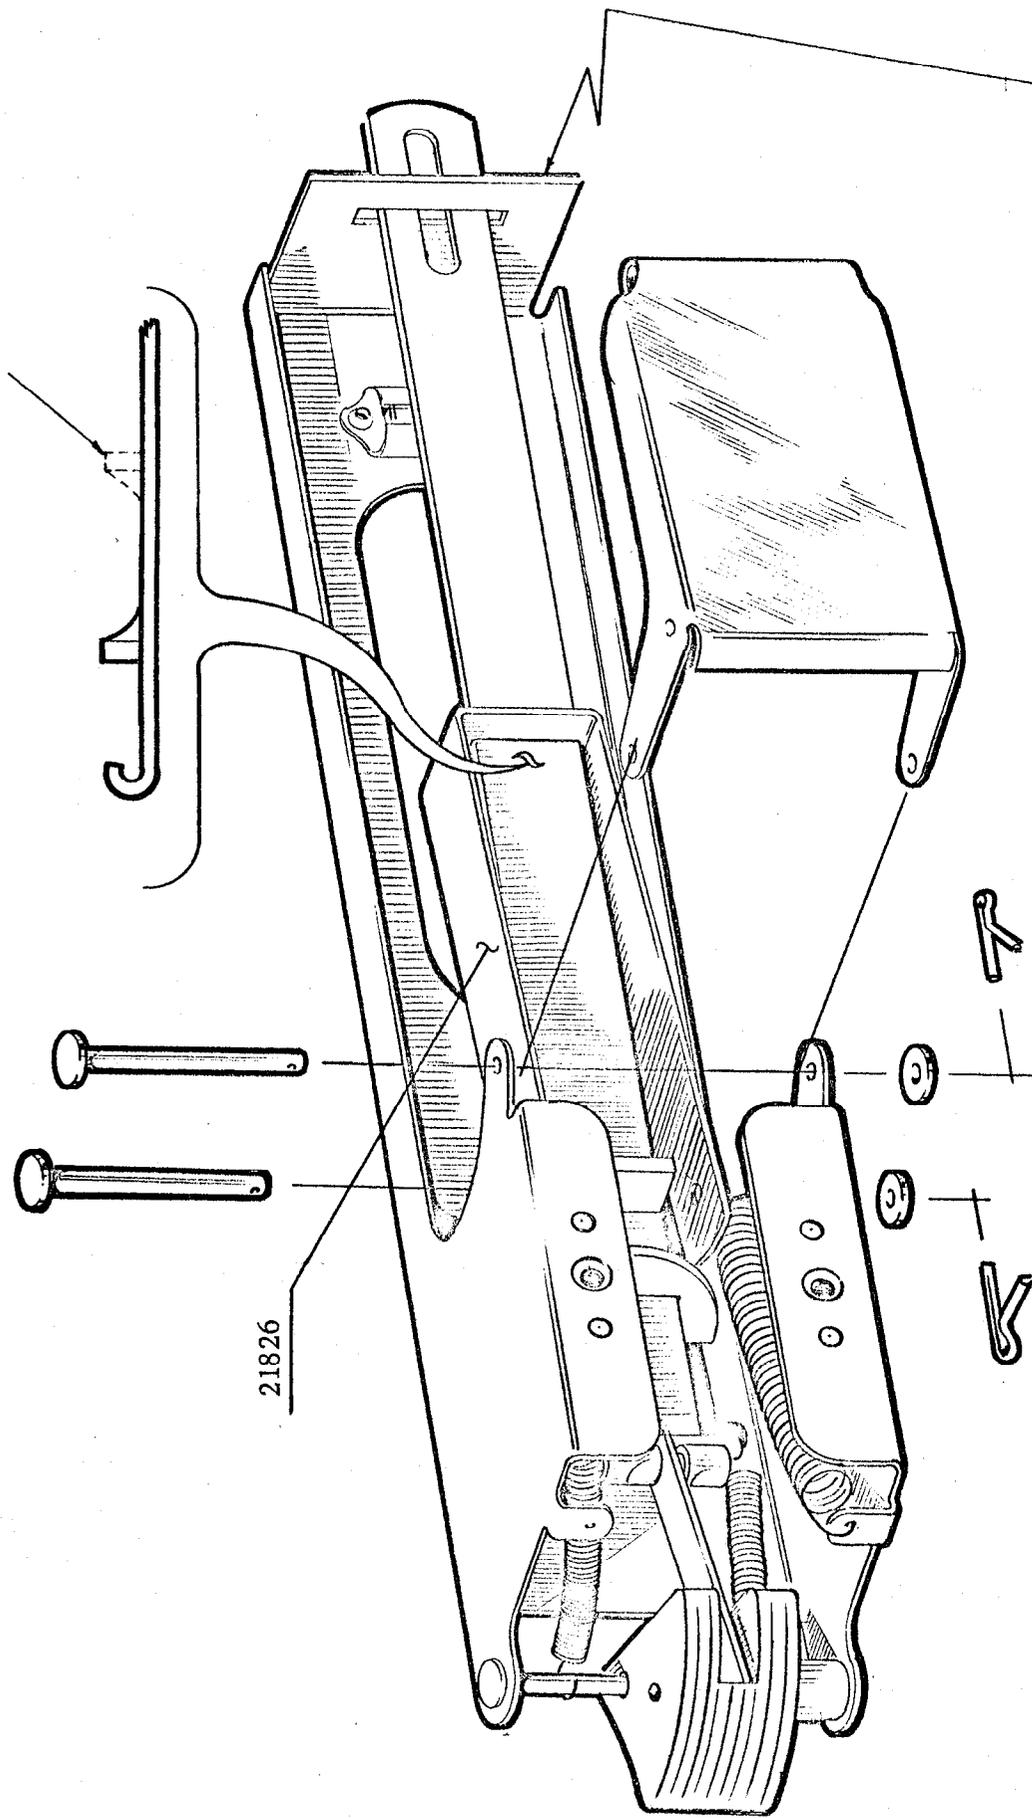
DOOR LATCH MODIFICATION	
SKETCH "A"	S.L. #305
PIPER AIRCRAFT CORPORATION	
LOCK HAVEN, PENNSYLVANIA

1. The main cabin door latch has been modified to provide a positive means of opening the door from the inside when it has been locked from the outside. We suggest that your door be revised as follows. Remove door latch assembly by loosening door trim upholstery and removing screws attaching latch plate and latch assembly to door frame. Disconnect latch pull rod from inside door handle and remove complete latch assembly. Modify latch assembly per Sketch "A" attached to this letter and install a new part number 21826.

BEND BACK TO LIBERATE
 END OF ACTUATING PLATE
 TO INSTALL PART NO. 21826

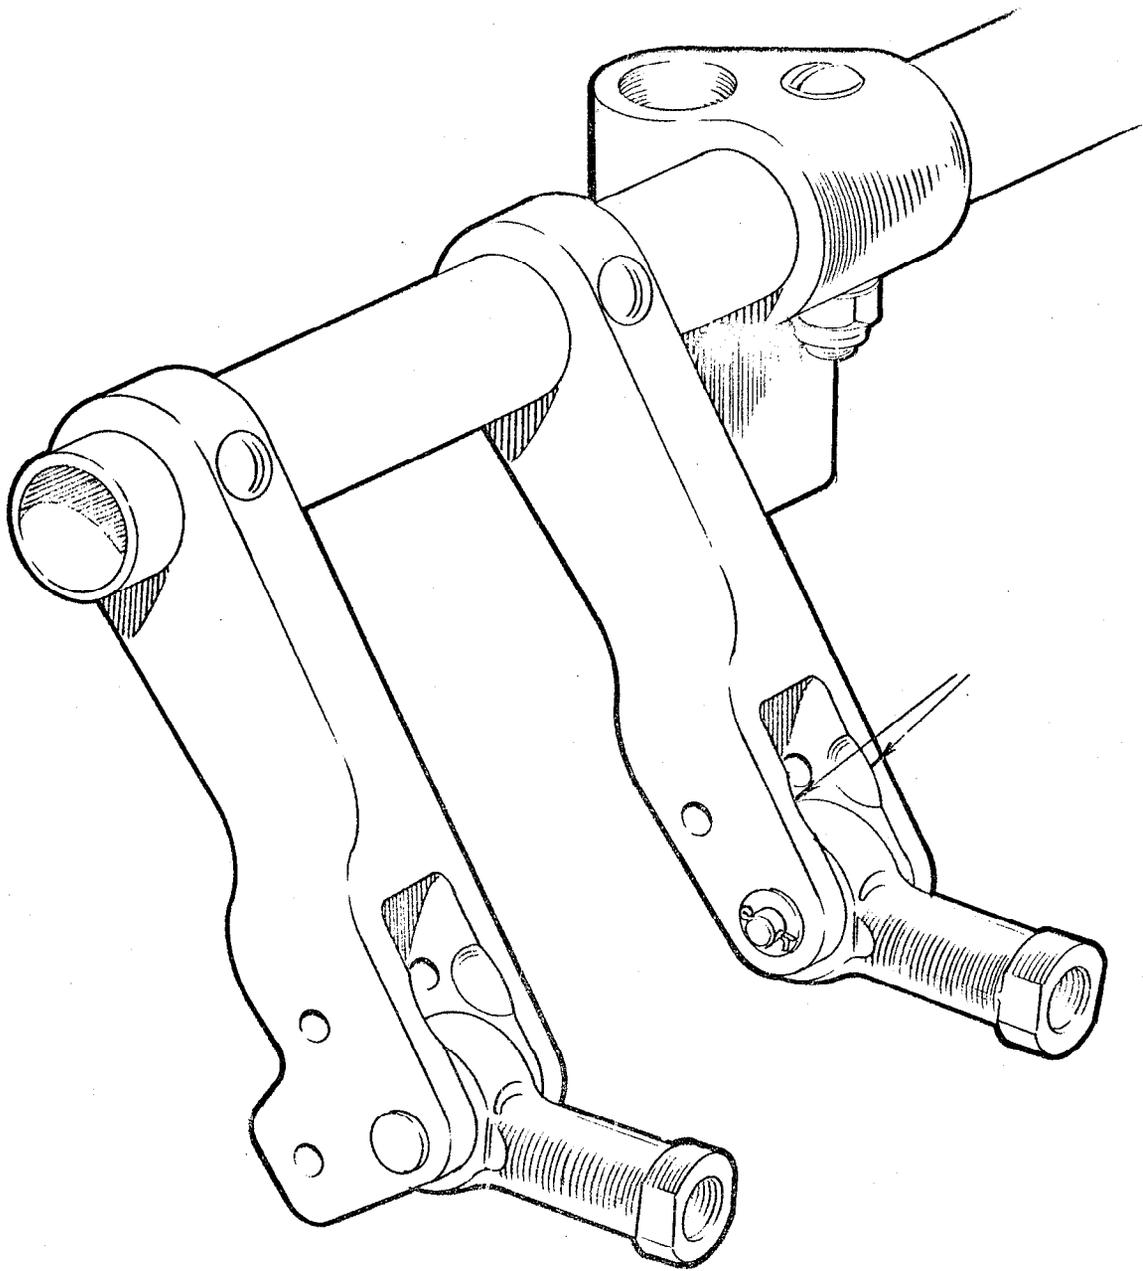
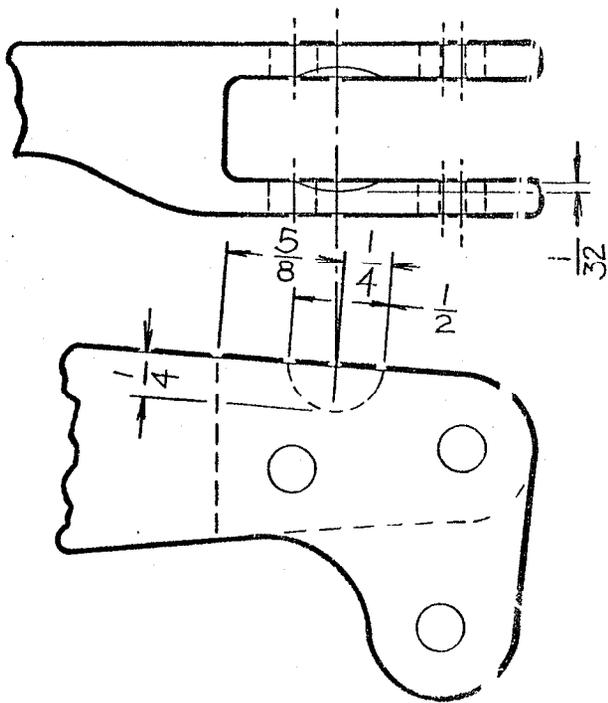
L. G. Retraction Tube Arms Modification	
SKETCH "C"	S. L. #305
PIPER AIRCRAFT CORPORATION	
LOCK HAVEN, PENNSYLVANIA

4. To prevent interference between the landing gear retraction tube arms and the retraction tube rod end bearings, the arms shall be modified per Sketch "C" attached to this letter.
