Service Letter No. 360

SUBJECT: Flap Retraction

MODELS AFFECTED: PA-24 and PA-24 "250" Comanches, Serials 24-1 to 24-356 inc., 24-358 to 24-1424 inc., 24-1426 to 24-2513 inc., 24-2515 to 24-2545 inc., 24-2549 to 24-2582 inc., 24-2584 to 24-2590 inc., 24-2593 to 24-2625 inc., 24-2627 to 24-2647 inc., 24-2649 to 24-2652 inc., 24-2655 to 24-2664 inc., 24-2666, 24-2668 to 24-2675 inc., 24-2677 to 24-2679 inc., 24-2681 to 24-2698 inc., 24-2700, 24-2701, 24-2702, 24-2704 to 24-2714 inc., 24-2716, 24-2718 to 24-2720 inc., 24-2722 to 24-2724 inc., 24-2726, 24-2728, 24-2730, 24-2732 to 24-2735 inc., 24-2737, 24-2738, 24-2742 to 24-2744 inc., 24-2746 to 24-2751 inc., 24-2755, 24-2758, 24-2761 to 24-2764 inc., 24-2770, 24-2773, 24-2774, 24-2776 to 24-2783 inc., 24-2787 to 24-2792, 24-2794, 24-2799, 24-2803, 24-2804, 24-2808 to 24-2810 inc., 24-2813, 24-2816, 24-2823, 24-2827, 24-2828, 24-2830, 24-2833 and 24-2834.

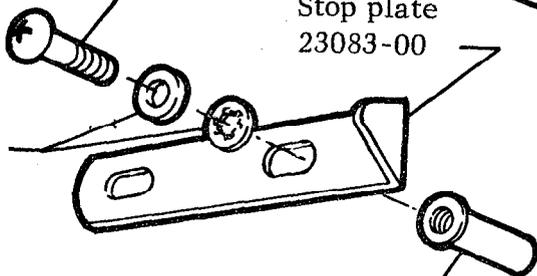
Field service reports indicate that in a few cases, under certain operating conditions, the flaps on the subject aircraft may, when retracted, extend beyond the normal, fully retracted position. This over-retraction of the flap or flaps has resulted when the flaps have been extended to aid in take-off and, later, retracted at airspeeds in excess of speeds recommended for flap operation.

Kit No. 754 413 consists of a flap stop plate for each flap, necessary hardware for its attachment and instructions for installation. This kit provides a positive stop for the flap retraction mechanism. Reference to the attached sketch may be made for details of installation. It is recommended that this kit be installed on all Comanche aircraft listed above for the serial numbers affected.

It is recommended that the operation of the flap retraction mechanism be checked, following the installation of Kit 754 413, to make certain the flap stop plates are correctly adjusted to prevent over-retraction of the flaps, as follows:

1. Retract flaps to fully retracted position.
2. Move the flap handle toward the extended position until the flaps are approximately one-third extended.
3. Release the flap handle gradually to the fully retracted position, maintaining flap load on the flap cables; simultaneously, with the assistance of a second person, apply pressure to the underside of each flap in an upward direction. Following the above directions will simulate flight load conditions on the flaps and the flap stop plates, when correctly adjusted, will prevent over-retraction of the flaps.
