Service Letter No. 417

Replacement of Fuel Injector Inlet Screens

PA-30 Twin Comanches, Serial No. 30-1 to 30-179 incl.

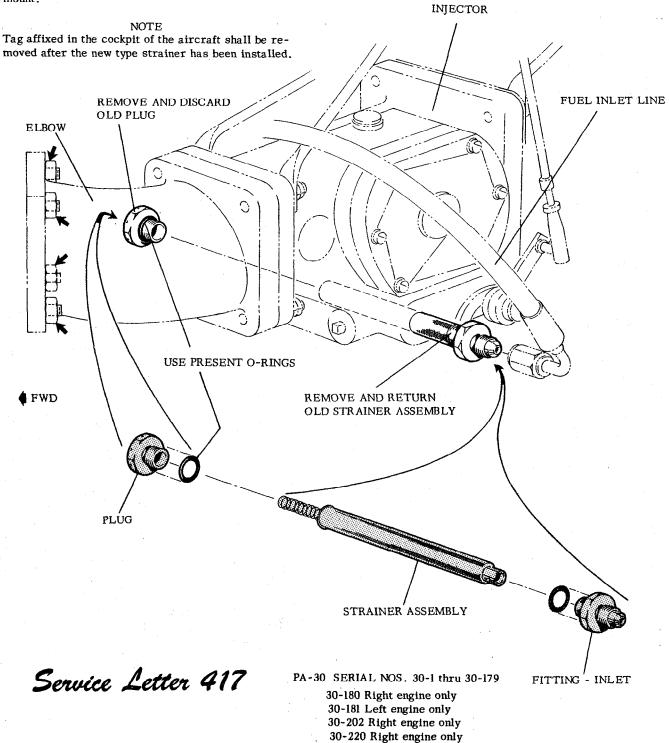
Loosen the four nuts holding the 45° injector turning elbow to the engine oil sump sufficiently to allow the downward rotation of the injector assembly so that the screen assembly will pass freely below the engine mount.

A fuel injector inlet screen replacement kit, part number 756 782, consisting of two fuel inlet fittings, two strainer assemblies and two plugs, which will facilitate removal and installation, is now available and shall be installed at or before the next 100 hour inspection in accordance with the sketch on the reverse side of this letter.
