Service Letter No. 419

Inspection of Heater Air Distribution Box Attachment

PA-30 Twin Comanches, Serial Numbers 30-1 to 30-278

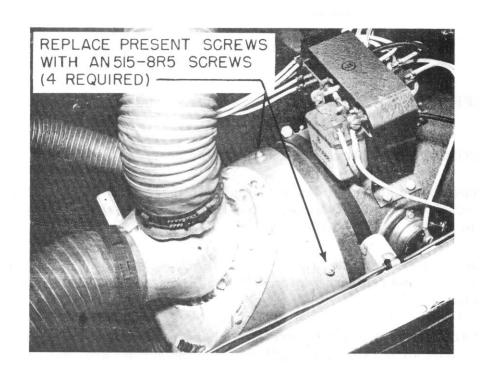
A report from the field has indicated that the heater air distribution box attachment screw in the subject aircraft may project through the heater outer shell far enough to contact the combustion chamber.

In order to correct this situation, the AN515-8R6 screw presently installed should be removed and replaced with an AN515-8R5 screw. See sketch on the reverse side of this letter.

The area of the heater combustion chamber directly under the four (4) screws should be checked for possible chafing at the time the screws are changed.
